**Flood Control Project Maintenance  
Levee Inspections**  
**LMA District Cover Sheet**  
**Spring 2020 Levee Inspection Results**

**Reclamation District No. 0017 Mossdale**

**Levee Inspection Report By Mile - Spring 2020**

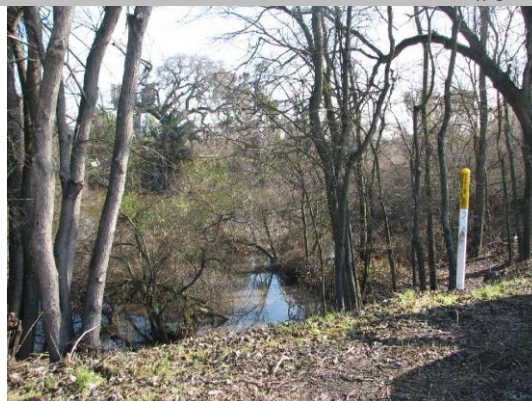
Photo 1 of 3 : UCIP\_SP\_2020\_40603\_38480.jpg

LM Start	0.03	Rating **	M	Issue No.	14
LM End	0.03	Issue Type +	En	Location *	
Category	Supplemental			GPS Latitude/Longitude	
				Start	End
Item	DWR UCIP Field Study			37.911561 °	37.911561 °
				-121.291441 °	-121.291441 °
DWR ID	1				
Comment Code					
Inspector Comment					
DS_ID:1 FS_ID:40603 EP_NO: 6623 Repair Type: Non-Urgent Crossing Status: Found UCIP Comments: Marker missing on landward side. Need to contact owner to determine status of crossing. Need date of last inspection and confirmation that crossing is still in operable condition. FIELD_STRUCT_DESC: 5.563-inch welded steel natural gas pipeline through the levees, 4.5 feet below the crown, across the channels and overflow area. (5-inch gas line authorized under Permit No. 6623, 1969 - Laymac Corporation) [Additional Reference(s): DWR Levee Logs, 1981, 2003]. FS Date: 2/3/2010

View of waterward side.

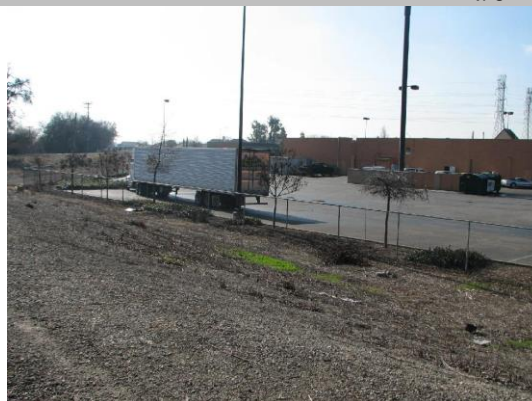
Photo 3 of 3 : UCIP\_SP\_2020\_40603\_38478.jpg

View of landward side.

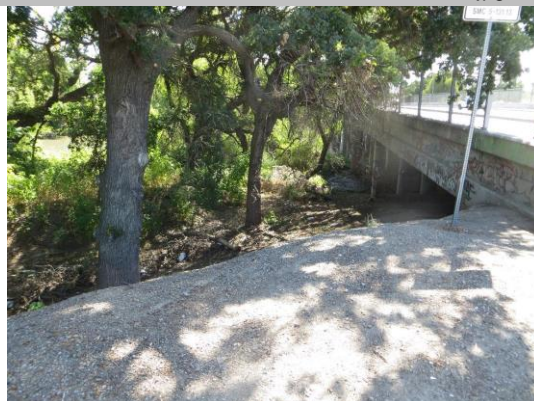
Photo 2 of 3 : UCIP\_SP\_2020\_49990\_74221.jpg

DS\_ID:72  
 FS\_ID:49990  
 EP\_NO: 15185  
 Repair Type: Non-Urgent  
 Crossing Status: Indicator Found  
 UCIP Comments: 04/06/2018 Received supporting information from T. Marlow with KSN pertaining to line. PG&E has installed gas line distribution markers on both shoulder of the levee. Crossing is an active line. PG&E performs a leak survey at least twice a year according to Mr. R. Muok, Supervisor, Gas Pipeline Operations and Maintenance Stockton. Mr. Muok can be reached at 209-406-7926. Crossing has been downgraded from Urgent to Non-Urgent--pipe is inspected by owner. UCIP will need to coordinate with PG&E to obtain confirmation of inspections, obtain emergency contact information, and maintenance contact information. (DWR UCIP - O. Magana)  
 07/12/2016 No markers (no photos taken in 2016). Need to contact owner to determine status of crossing. If crossing is active, owner will need to coordinate with CVFPB to install markers to comply with Title 23. (DWR UCIP - omagana)5/19/2015 Need to install gasline markers. (DWR UCIP - omagana)

WS Slope. No gasline markers.

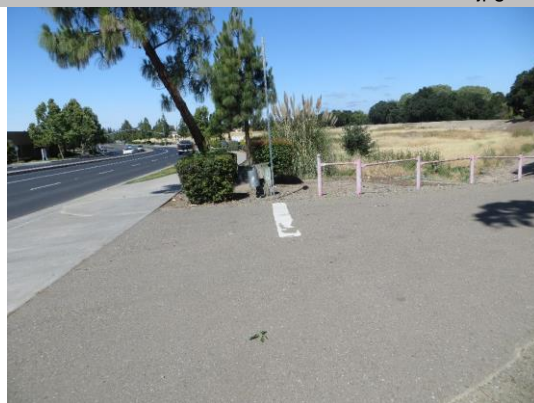
Photo 3 of 3 : UCIP\_SP\_2020\_49990\_74220.jpg

LS crown. No gasline markers.

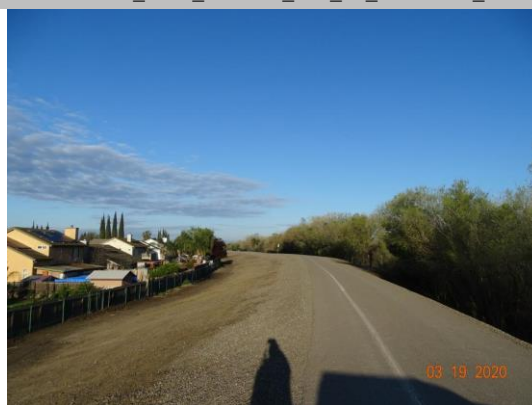
Photo 1 of 1 : SP\_2020\_RD0017\_303\_12\_20200323\_00018.jpg

LM Start	1.02	Rating **	A	Issue No.	12
LM End	1.02	Issue Type +	Ma	Location *	LS
Category	Earthen Levee			GPS Latitude/Longitude	
				Start	End
Item	Vegetation			37.915650 °	37.915650 °
				-121.307253 °	-121.307253 °
DWR ID	DWR_RD0017_01_s_2020_12				
Comment Code					
V1 : Control annual grass and weeds on the levee slopes and easements.					
Inspector Comment

Typical view of well maintained vegetation on landside slope. Spring 2020

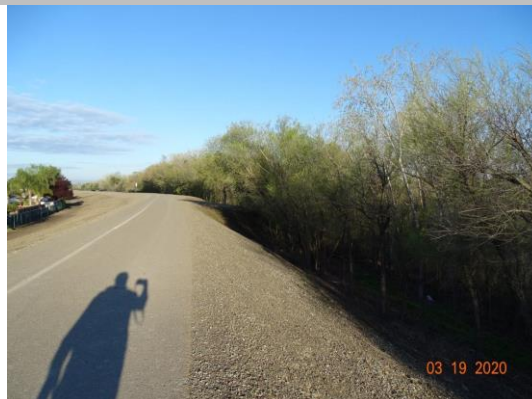
Photo 1 of 1 : SP\_2020\_RD0017\_303\_13\_20200323\_00019.jpg

LM Start	1.02	Rating **	A	Issue No.	13
LM End	1.02	Issue Type +	Ma	Location *	WS
Category	Earthen Levee			GPS Latitude/Longitude	
				Start	End
Item	Vegetation			37.915650 °	37.915650 °
				-121.307254 °	-121.307254 °
DWR ID	DWR_RD0017_01_s_2020_13				
Comment Code					
V1 : Control annual grass and weeds on the levee slopes and easements.					
Inspector Comment

Typical view of well maintained vegetation on waterside slope. Spring 2020

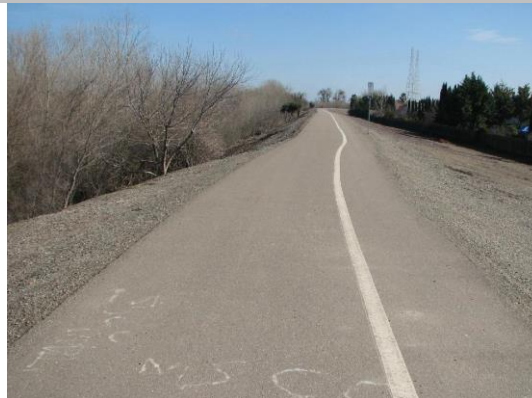
Photo 1 of 3 : UCIP\_SP\_2020\_40604\_38491.jpg

DS\_ID:2  
 FS\_ID:40604  
 EP\_NO: 14992  
 Repair Type: Non-Urgent  
 Crossing Status: Indicator Found  
 UCIP Comments: Need to contact owner to determine status of crossing. Also need date of last inspection.  
 FIELD\_STRUCT\_DESC: [Weston Ranch - French Camp Slough Crossings] 1 of 3. 30-inch high-density polyethylene (HDPE) sewer force main (SFM) through the levee, 32 feet below levee crown. All pipes encased in concrete. (two 30-inch force mains (originally issued as 27-inch) and one 12-inch pipe authorized under Permit No. 14992, 1989 - City of Stockton and Richard Blewett) [Additional Reference(s): DWR Levee Logs, 1981, 2003]  
 FS Date: 2/3/2010

Overview of levee crown at crossing.

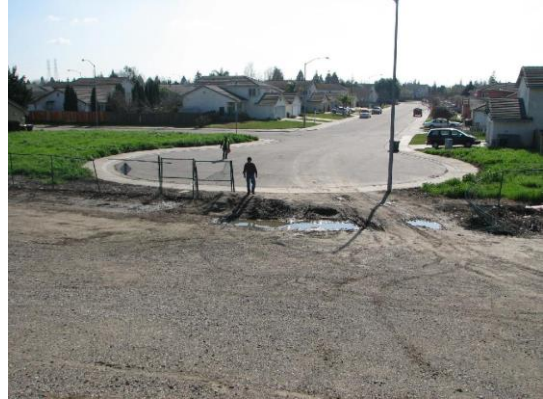
Photo 2 of 3 : UCIP\_SP\_2020\_40604\_38489.jpg

View of landward side.

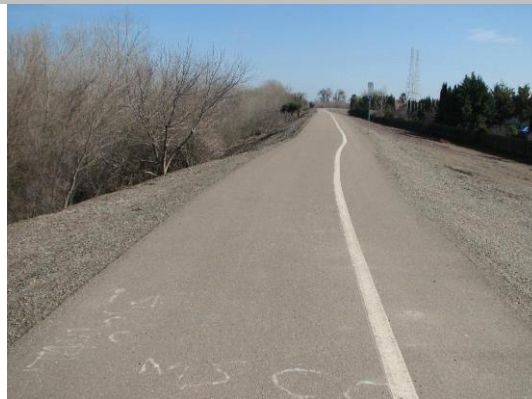
Photo 1 of 3 : UCIP\_SP\_2020\_52614\_38505.jpg

Comment Code						
Inspector Comment						
DS_ID:159 FS_ID:52614 EP_NO: 14992 Repair Type: Non-Urgent Crossing Status: Indicator Found UCIP Comments: Need to contact owner to determine status of crossing. Also need date of last inspection. FIELD_STRUCT_DESC: [Weston Ranch - French Camp Slough Crossings] 2 of 3. 30-inch high-density polyethylene (HDPE) sewer force main (SFM) through the levee, 32 feet below levee crown. All pipes encased in concrete. (two 30-inch force mains (originally issued as 27-inch) and one 12-inch pipe authorized under Permit No. 14992, 1989 - City of Stockton and Richard Blewett) [Additional Reference(s): DWR Levee Logs, 1981, 2003] FS Date: 2/3/2010

Overview of levee at crossing.

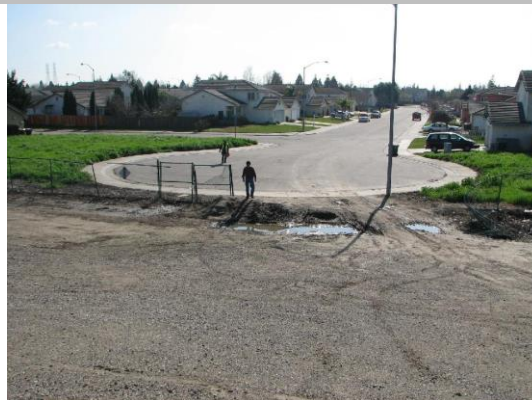
Photo 2 of 3 : UCIP\_SP\_2020\_52614\_38503.jpg

View of landward toe--established neighborhood.

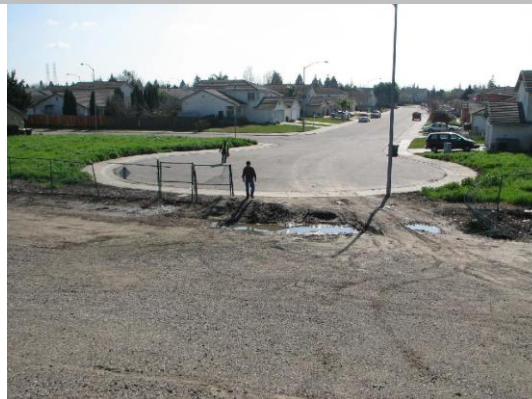
Photo 2 of 3 : UCIP\_SP\_2020\_40606\_71941.jpg

View of landward side.

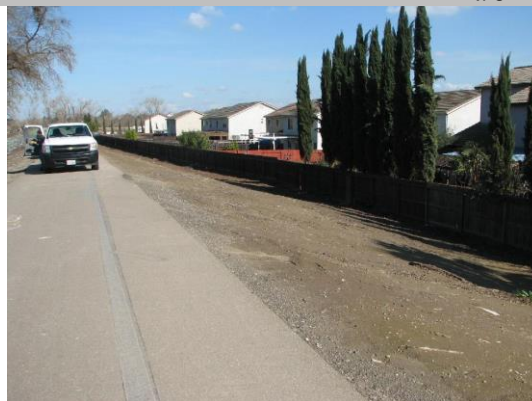
Photo 1 of 3 : UCIP\_SP\_2020\_40628\_38516.jpg

Comment Code						
Inspector Comment						
DS_ID:75 FS_ID:40628 EP_NO: 15093 Repair Type: Non-Urgent Crossing Status: Found UCIP Comments: Only appurtenances remaining at this location--4 pillings located on waterward side. According to records the pillings were to be removed under a completion maintenace contract. Need to coordinate with owner. FIELD_STRUCT_DESC: 14-inch-diameter pipeline through levee at unknown depth. Per inspector's notes "this crossing is abandoned almost all materials removed including pipes, conduit, and pump house. The only items left are 4 pilings which are to be removed under a completion maintenance contract. Approximately 200 feet of reinforced concrete pipe lateral removed in R/W south of crossing". FS Date: 2/3/2010

View of landward side.

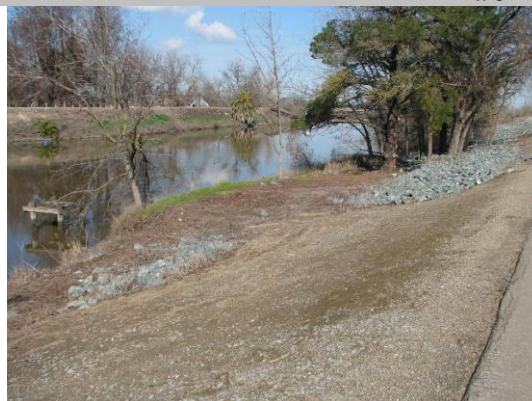
Photo 3 of 3 : UCIP\_SP\_2020\_40628\_38514.jpg

View of waterward side.

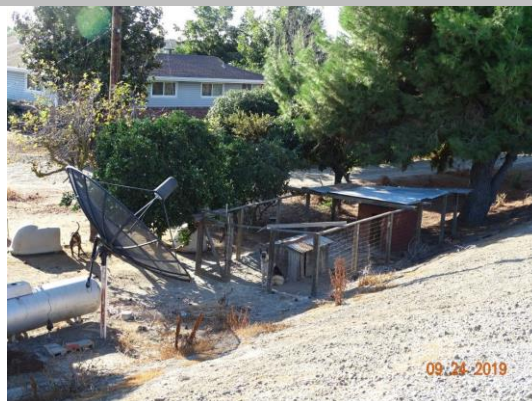
Photo 1 of 1 : SP\_2020\_RD0017\_304\_73\_20200228\_00002.jpg

LM Start	1.13	Rating **	M	Issue No.	73
LM End	1.13	Issue Type +	En	Location *	LS
Category	Earthen Levee			GPS Latitude/Longitude	
				Start	End
Item	Encroachments			37.901693 °	37.901693 °
				-121.325582 °	-121.325582 °
DWR ID	DWR_RD0017_02_s_2017_73				
Comment Code					
BU : Building					
Inspector Comment					
Dog kennels are within flood control right of way.

View of dog kennels within flood control right of way on landside slope.  
Fall 2019

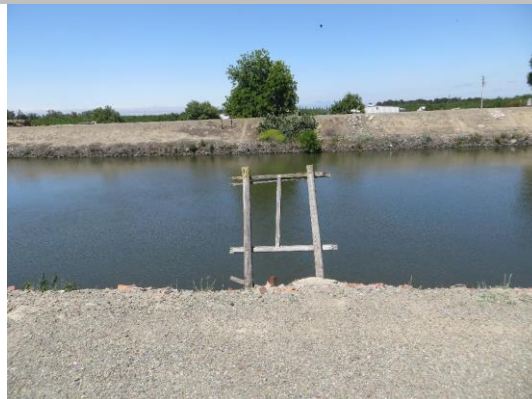
Photo 1 of 2 : UCIP\_SP\_2020\_45449\_74105.jpg

LM Start	1.18	Rating **	M	Issue No.	98
LM End	1.18	Issue Type +	En	Location *	
Category	Supplemental			GPS Latitude/Longitude	
				Start	End
Item	DWR UCIP Field Study			37.901012 °	37.901012 °
				-121.325497 °	-121.325497 °
DWR ID	9				
Comment Code					
Inspector Comment					
DS_ID:9					
FS_ID:45449					
EP_NO: N/A					
Repair Type: Non-Urgent					
Crossing Status: Indicator Found					
UCIP Comments: Appears abandoned. Should contact owner to determine status as signs have been removed from supports and should be replaced if still in service.					
FIELD_STRUCT_DESC: Underground telephone cable through levee, 2 feet below crown. Warning signs on waterside (WS) slope. [Additional Reference(s): DWR Levee Logs, 1981, 2003]					
FS Date: 5/19/2015

Sign on WS slope.

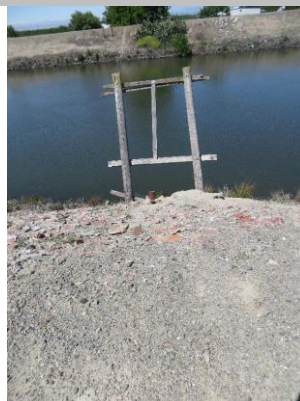
Photo 1 of 2 : UCIP\_SP\_2020\_45450\_74107.jpg

LM Start	1.18	Rating **	M	Issue No.	99
LM End	1.18	Issue Type +	En	Location *	
Category	Supplemental			GPS Latitude/Longitude	
				Start	End
Item	DWR UCIP Field Study			37.901012 °	37.901012 °
				-121.325497 °	-121.325497 °
DWR ID	308				
Comment Code					
Inspector Comment					
DS_ID:308 FS_ID:45450 EP_NO: N/A Repair Type: Non-Urgent Crossing Status: Indicator Found UCIP Comments: Appears Abandoned. Need to contact owner to determine status of crossing as signs have been removed from markers and should be replaced if still in service. FIELD_STRUCT_DESC: 4-inch submarine telephone cable of unknown material through the levee, 2 feet below the crown, and across the channel. Location marker on the waterside (WS) slope. [Additional Reference(s): DWR Levee Logs, 1981, 2003] FS Date: 5/19/2015

Sign post on WS slope.

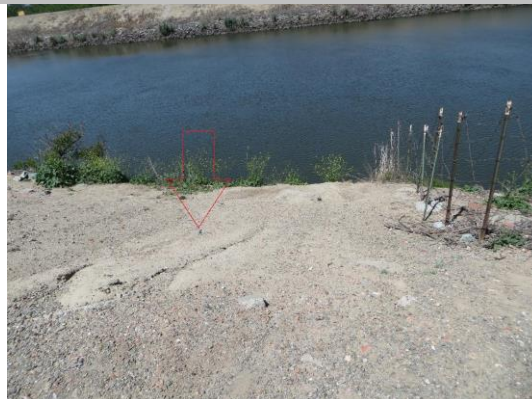
Photo 1 of 2 : UCIP\_SP\_2020\_49637\_74109.jpg

Comment Code					
Inspector Comment					
DS_ID:10 FS_ID:49637 EP_NO: 15098 Repair Type: Non-Urgent Crossing Status: Indicator Found UCIP Comments: 5/19/2015 Only signs of electrical conduit found. Need to contact owner to determine status of pipe as no record of removal has been found and only an electrical conduit was found at this location. (DWR UCIP - W. Wylie) FIELD_STRUCT_DESC: 8-inch steel irrigation pipe through the levee, 3.3 feet below levee crown. Electrical conduit through levee. Pump house located on waterside (WS) berm. Siphon breaker on WS shoulder, standpipe located 10 feet from landside (LS) toe. (8-inch pipe authorized under Permit No. 15098, 1989 - G. La Baume, permit also includes authorization of 12-inch pipe at different location). [Additional Reference(s): DWR Levee Logs, 1981, 2003] FS Date: 5/19/2015

View of WS slope with electrical conduit.

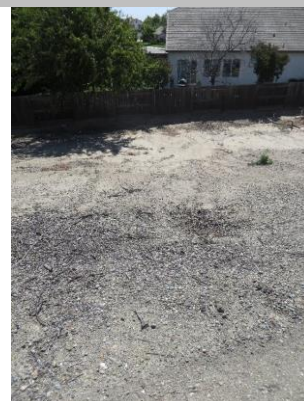
Photo 2 of 2 : UCIP\_SP\_2020\_49637\_74108.jpg

View of LS. No appurtenances noted.

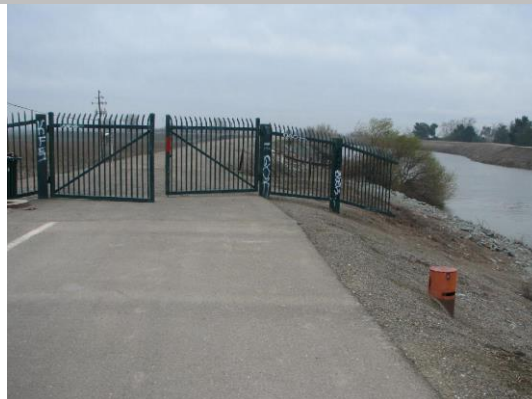
Photo 1 of 3 : UCIP\_SP\_2020\_40639\_38687.jpg

Comment Code						
Inspector Comment						
DS_ID:11						
FS_ID:40639						
EP_NO: 15316						
Repair Type: Non-Urgent						
Crossing Status: Indicator Found						
UCIP Comments: Need to contact owner to determine status--pipe was not found only siphon breaker housing unit.						
FIELD_STRUCT_DESC: 8-inch steel drainage pipeline through levee, 3 feet below levee crown. Siphon breaker on the waterside (WS) shoulder. Pump is located inside ditch located approximately 75 feet landside (LS) of levee toe. (8-inch pipe authorized under Permit No. 15316, 1989 - W. Long and Reclamation No. 17 [RD0017], 10-inch pipe also installed) [Additional Reference(s): DWR Levee Logs, 1981, 2003, 8-inch pipe listed]						
FS Date: 2/4/2010

View of levee crown at crossing.

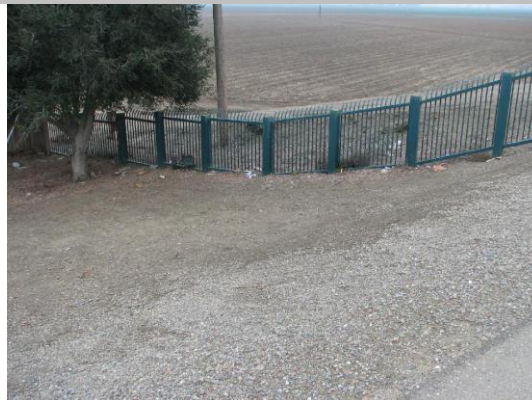
Photo 2 of 3 : UCIP\_SP\_2020\_40639\_38686.jpg

View of landward side.

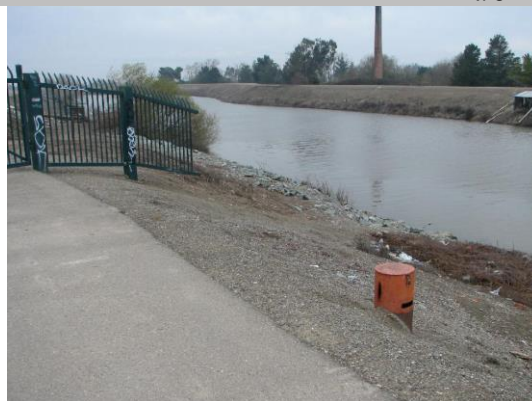
Photo 3 of 3 : UCIP\_SP\_2020\_40639\_38685.jpg

Siphon breaker located on waterward slope.

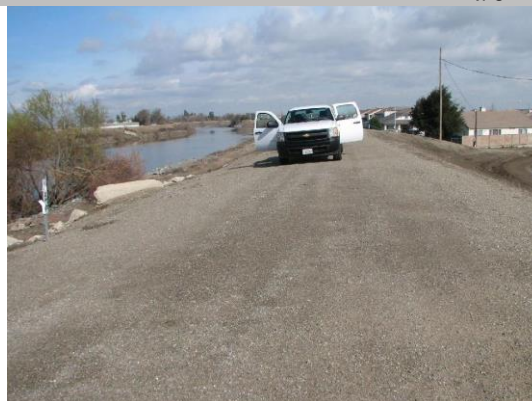
Photo 1 of 3 : UCIP\_SP\_2020\_40640\_71981.jpg

DS\_ID:12  
 FS\_ID:40640  
 EP\_NO: 15099  
 Repair Type: Non-Urgent  
 Crossing Status: Found  
 UCIP Comments: Need to coordinate with owner to determine status of crossing. If crossing is no longer in use owner will need to contact the CVFPB to comply with Title 23.  
 FIELD\_STRUCT\_DESC: 16-inch steel irrigation pipe through levee, 2.30 feet below levee crown. Siphon breaker on waterside (WS) shoulder. Pump house located on the WS berm. Standpipe located 15 feet from landside (LS) toe. Concrete stairway on WS slope. (16-inch pipe removed under Permit No. 15099, 1989 - W. Long, 12-inch pipe removed) [Additional Reference(s): DWR Levee Logs, 1981, 2003]  
 FS Date: 2/4/2010

View of levee crown at crossing.

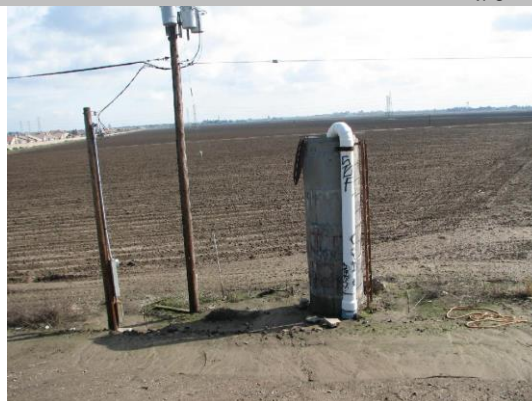
Photo 2 of 3 : UCIP\_SP\_2020\_40640\_38706.jpg

Standpipe located on landward side.

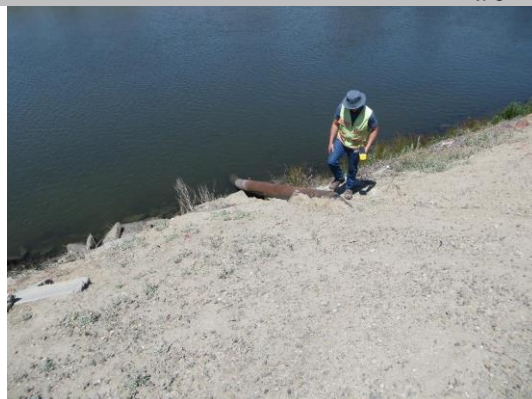
Photo 1 of 3 : UCIP\_SP\_2020\_49640\_74436.jpg

DS\_ID:13  
FS\_ID:49640  
EP\_NO: 15100  
Repair Type: Non-Urgent  
Crossing Status: Found  
UCIP Comments: 09/07/2016 Need to coordinate with owner to determine if 12-inch pipe was sleeved through authorized 16-inch pipe. Unable to confirm if 12-inch pipe was authorized under Permit No. 15100. Also need to coordinate with owner to determine extent of repair to crossing--previous leak to WS pipe section. (DWR UCIP - O. Magana)05/19/2015 Notes were initially recorded under DS\_ID entry 82 due to field confirmed pipe size (12-inch and not 16-inch as described in permit). Record was updated to show 12 inch crossing was authorized under Permit 15100. UPDATED INFO @ CROSSING: Damage pipe section located on waterward toe has been replaced with new section. (DWR UCIP - O. Magana)02/0/2010 Holes in pipe at WS toe good indicator of pipe internal condition. Owner should perform an internal inspection of the pipe through the levee. (DWR UCIP - O. Magana)

(2015) Damage pipe section located on WS toe has been replaced.

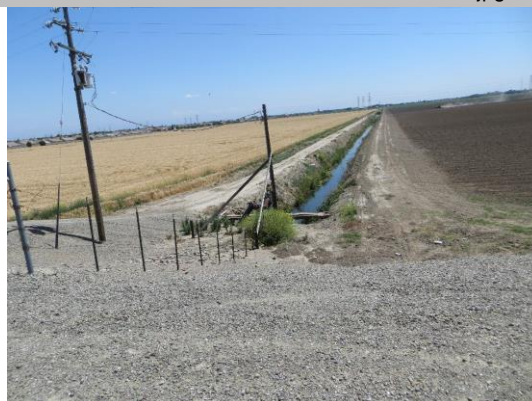
Photo 2 of 3 : UCIP\_SP\_2020\_49640\_74437.jpg

(2015) View of landward side.

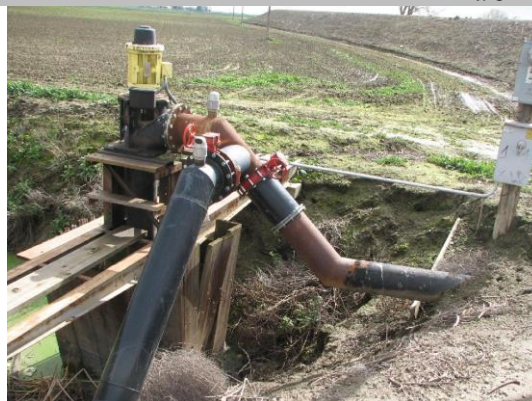
Photo 3 of 3 : UCIP\_SP\_2020\_49640\_74432.jpg

Pump, vent, butterfly valve, and pipe visible off LS toe.

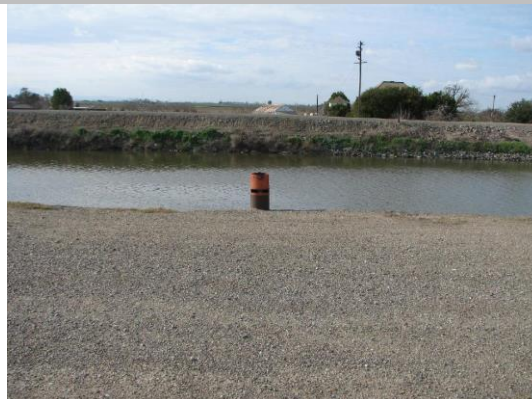
Photo 1 of 3 : UCIP\_SP\_2020\_40642\_38742.jpg

Comment Code						
Inspector Comment						
DS_ID:14 FS_ID:40642 EP_NO: 15317 Repair Type: Non-Urgent Crossing Status: Found UCIP Comments: Need to coordinate with owner to determine status of crossing. Need to find out if pipe located on landward side is tied to pipe through levee. Pipe found on waterward side is filled with concrete (non-functional). FIELD_STRUCT_DESC: 10-inch steel drainage pipe through levee, 3.91 feet below levee crown. Siphon breaker on waterside (WS) slope. Pump in ditch located 300 feet landside (LS) of toe. Ramp on LS slope. 10-inch pipe connects to an existing 16-inch discharge pipe on the LS. (10-inch installed under Permit No. 15317, 1990 - Calcagno Farms and Reclamation District 17 [RD0017], 16-inch section from levee removed; 10-pipe was installed during the levee work approved under Permit No. 15014, 1989 - RD0017). [Additional Reference(s): DWR Levee Logs, 1981, 2003] FS Date: 2/4/2010

View of waterward side--riser located on waterward shoulder.

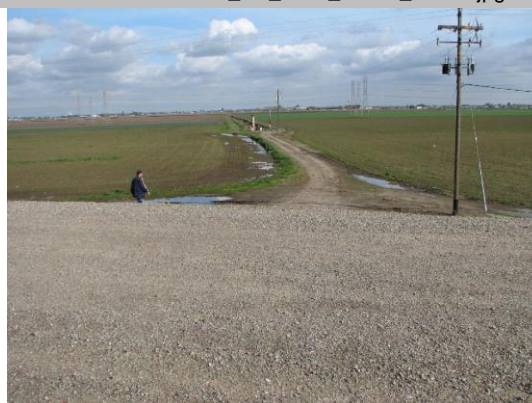
Photo 2 of 3 : UCIP\_SP\_2020\_40642\_38740.jpg

View of landward side.

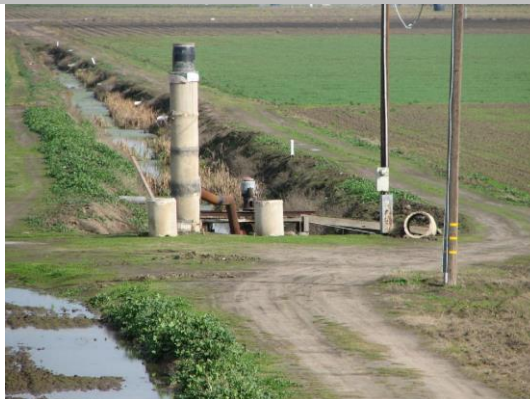
Photo 3 of 3 : UCIP\_SP\_2020\_40642\_38746.jpg

Unidentified appurtenances located on landward side-unable to confirm if pipe crosses levee.

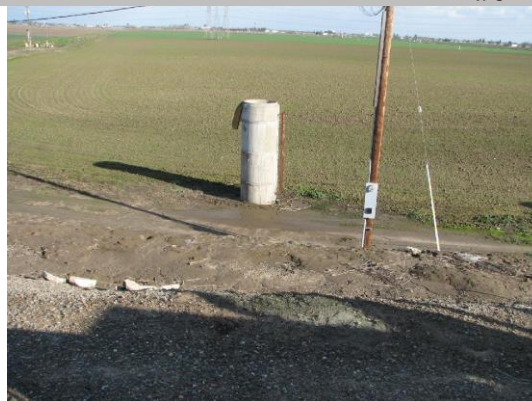
Photo 1 of 3 : UCIP\_SP\_2020\_49992\_38770.jpg

DS\_ID:15  
FS\_ID:49992  
EP\_NO: 15101  
Repair Type: Non-Urgent  
Crossing Status: Found  
UCIP Comments: 7/12/2016 Rodent activity is present at this crossing. Unable to confirm if sink hole was present--depression near riser is still visible. Pipe was running during site visit. Crossing has been downgraded from Urgent to Non-Urgent---no damage was visible to levee crown or LS slope and only minor depression found around WS riser. Depression near siphon breaker on WS shoulder could be due to poor compaction or rodent activity--recommend monitoring site. Need to contact owner to determine if any internal integrity inspections have been done at this crossing. (DWR UCIP - omagana)2/04/2010 Sink hole present at siphon breaker riser located on waterward shoulder. Need to coordinate with owner to determine status of crossing. If crossing is no longer in use owner will need to contact the CVFPB to comply with Title 23. (DWR UCIP - omagana)

View of LS.

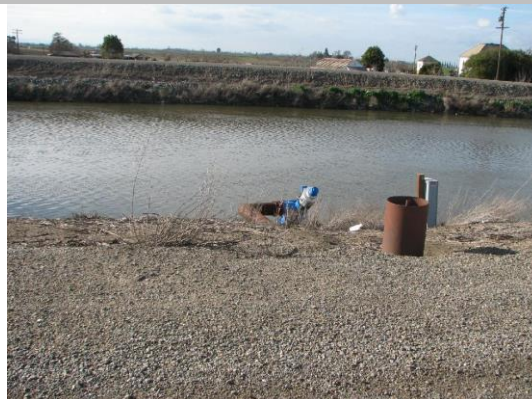
Photo 2 of 3 : UCIP\_SP\_2020\_49992\_38773.jpg

View of WS.

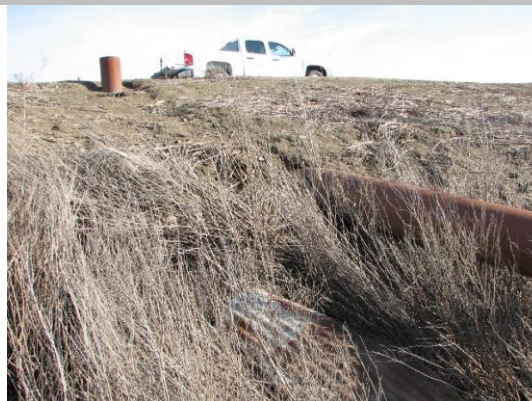
Photo 3 of 3 : UCIP\_SP\_2020\_49992\_38774.jpg

View of WS slope--riser and pipe visible.

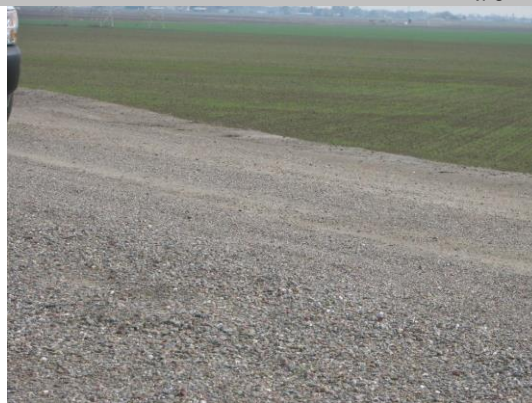
Photo 1 of 3 : UCIP\_SP\_2020\_40645\_72002.jpg

Comment Code						
Inspector Comment						
DS_ID:16 FS_ID:40645 EP_NO: 15102 Repair Type: Non-Urgent Crossing Status: Found UCIP Comments: Need to coordinate with owner to determine status of crossing. FIELD_STRUCT_DESC: 20-inch steel irrigation pipeline through levee. Invert of pipe is 2.8 feet below levee crown. Fill placed over the pipeline to provide 2.0 feet of cover. Siphon breaker on waterside (WS) shoulder. Pump on platform with walkway to shoulder, standpipe located 15 feet landside (LS) toe, concrete stairway en waterside (WS) slope. (20-inch pipe installed under Permit No. 15102, 1990 - Calcagno Farms Co-Partnership, also 24-inch pipe removed; 20-inch pipe was installed during the levee work approved under Permit No. 15014, 1989 - Reclamation District 17 [RD0017]). [Additional Reference(s): DWR Levee Logs, 1981, 2003] FS Date: 2/4/2010

View of levee crown at crossing.

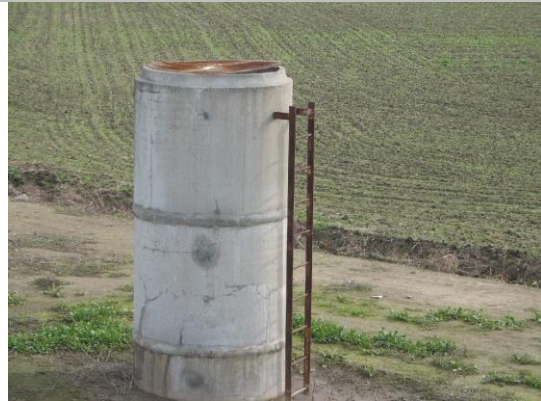
Photo 2 of 3 : UCIP\_SP\_2020\_40645\_72001.jpg

Standpipe located on landward toe.

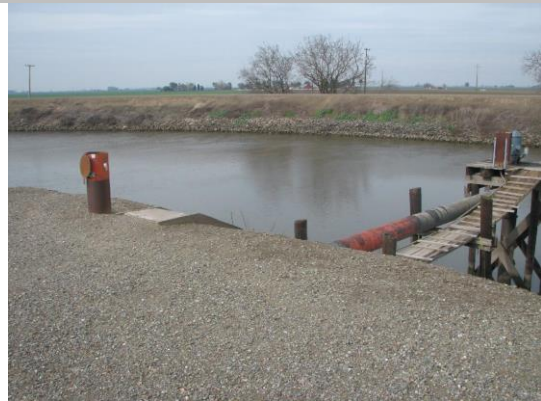
Photo 3 of 3 : UCIP\_SP\_2020\_40645\_72006.jpg

Overview of waterward side.

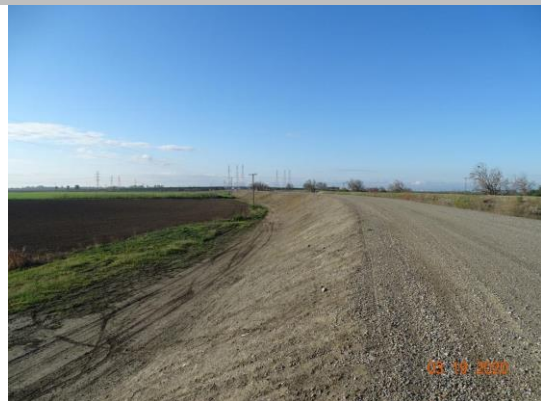
Photo 1 of 1 : SP\_2020\_RD0017\_304\_67\_20200323\_00186.jpg

Typical view of well maintained vegetation on landside slope. Spring 2020

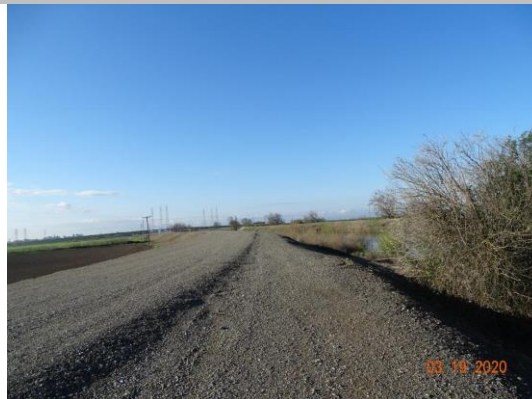
Photo 1 of 1 : SP\_2020\_RD0017\_304\_68\_20200323\_00187.jpg

Typical view of well maintained vegetation on waterside slope. Spring 2020

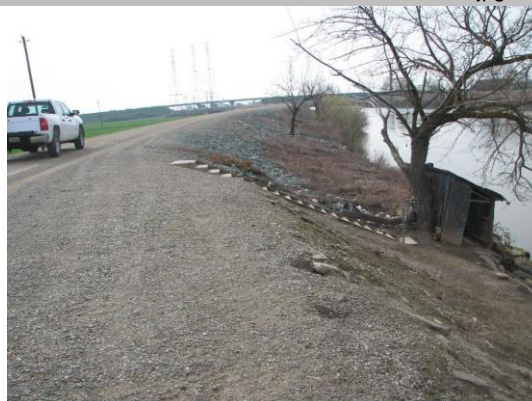
Photo 1 of 3 : UCIP\_SP\_2020\_40646\_72010.jpg

Comment Code						
Inspector Comment						
DS_ID:17 FS_ID:40646 EP_NO: 15103 Repair Type: Non-Urgent Crossing Status: Found UCIP Comments: Need to coordinate with owner to determine status of crossing. If crossing is no longer in use owner will need to contact the CVFPB to comply with Title 23. FIELD_STRUCT_DESC: 8-inch steel irrigation pipe through levee. Invert of pipe is 3.47 feet below crown. Siphon breaker on landside (LS) shoulder. Pump house on waterside (WS) slope, standpipe located 10 feet from LS toe. Concrete stairway on WS slope. (new 8-inch authorized under Permit No. 15103, 1990 - C. Young, existing 8-inch pipe removed; new 8-inch pipe was installed during the levee work approved under Permit No. 15014) [Additional Reference(s): DWR Levee Logs, 1981, 2003] FS Date: 2/4/2010

View of waterward side.

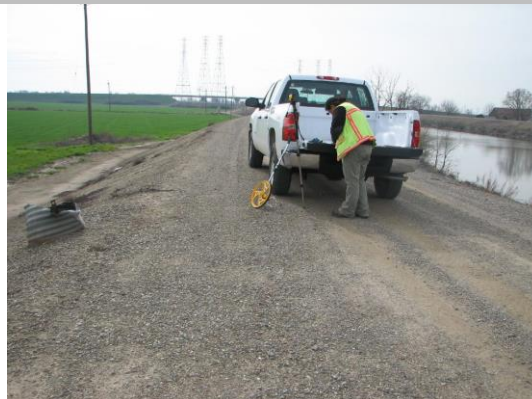
Photo 2 of 3 : UCIP\_SP\_2020\_40646\_72009.jpg

View of levee crown at crossing.

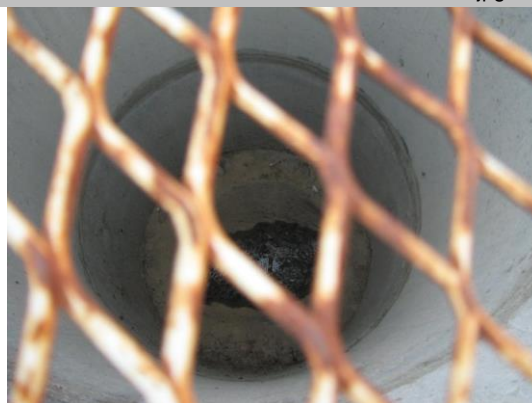
Photo 3 of 3 : UCIP\_SP\_2020\_40646\_72008.jpg

Inside view of standpipe located on landward side.

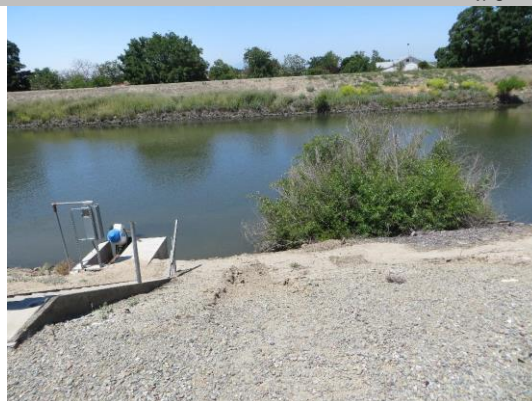
Photo 1 of 3 : UCIP\_SP\_2020\_46009\_74439.jpg

Comment Code						
Inspector Comment						
DS_ID:315 FS_ID:46009 EP_NO: N/A Repair Type: Non-Urgent Crossing Status: Found UCIP Comments: 05/19/15 Pipe has been removed. Need to contact KSN, engineering consultants for LMA, to obtain records showing pipe removal and obtain permit authoring work. 02/04/10 Hole present on waterward side pipe--historical records indicate crossing abandoned however unable to confirm. Unable to confirm condition of pipe through levee. Need to coordinate with owner to determine status of crossing. If crossing is no longer in use owner will need to contact the CVFPB to comply with Title 23. FIELD_STRUCT_DESC: *REMOVED* 4-inch irrigation pipe of unknown material through the levee, 2 feet below the crown. Pipe open on both ends, waterside (WS) and landside (LS). Pump on concrete pad and gate valve located on the WS slope. [Additional Reference(s): DWR Levee Logs, 1981, 2003] FS Date: 5/19/2015

(2015) View of waterward slope.

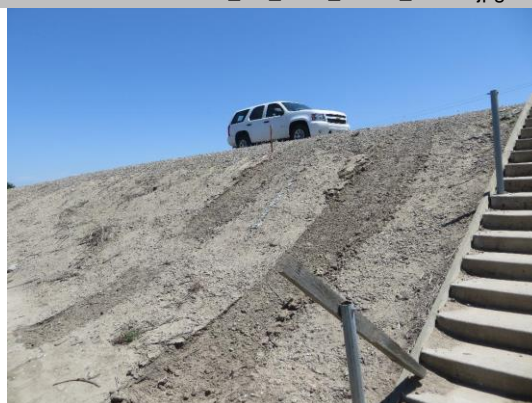
Photo 2 of 3 : UCIP\_SP\_2020\_46009\_74441.jpg

(2015) View of waterward slope--pipe removed.

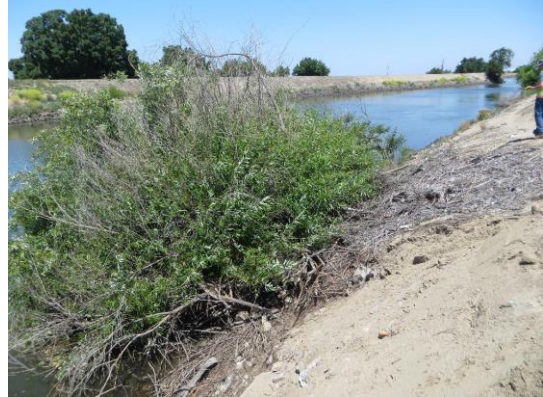
Photo 3 of 3 : UCIP\_SP\_2020\_46009\_74438.jpg

(2015) Pipe removed from waterward toe.

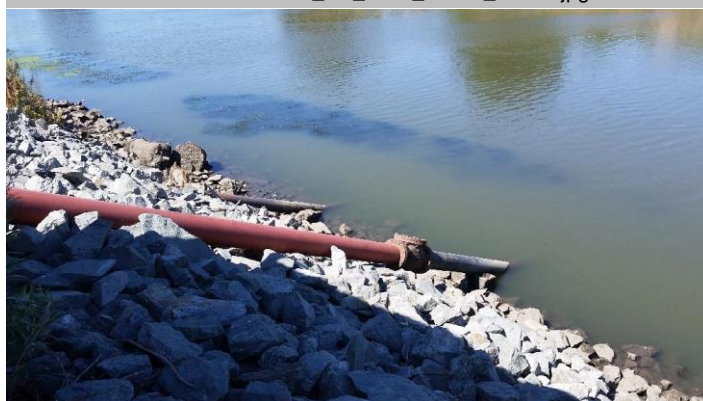
Photo 1 of 3 : UCIP\_SP\_2020\_53329\_75736.jpg

DS\_ID:278  
FS\_ID:53329  
EP\_NO: 15104  
Repair Type: Urgent  
Crossing Status: Found  
UCIP Comments: 9/5/2018 Same as last inspection. Recommend contacting owner to see if crossing still in use. Crossing remains Urgent because of pipe integrity (D. Sanoski - DWR UCIP).7/12/2016 Same as previous inspection. Holes visible along exposed WS section of pipe. (DWR UCIP - omagana)5/19/2015 Holes through pipe visible on waterward toe. Recommend contacting owner to confirm pipe use--good candidate for internal inspection. (DWR UCIP - omagana)2/04/2010 Need to coordinate with owner to determine status of crossing. If crossing is no longer in use owner will need to contact the CVFPB to comply with Title 23. (DWR UCIP - omagana) FIELD\_STRUCT\_DESC: 8-inch steel irrigation pipe through the levee, 2.85 feet below levee crown. Pump station is located on waterside (WS). Concrete standpipe is located on the landside (LS) toe. (8-inch pipe authorized under Permit No. 15104, 1989-R. Romonda & C. Young, permit covers 4 pipe crossing removals and 3 new pipe installations; levee re-shaping authorized under Permit No. 15014, 1989 - Reclamation District 17 [RD0017]; pipe was installed as part of the re-shaping of RD17 project levees in 1989. The re-shaping of the levees was to increase levee elevations and provide freeboard above 100-year stages in both the San Joaquin River and French Camp Slough) [Additional Reference(s): DWR Levee Log, 1981 and 2003]

View of WS, photo taken downstream looking at upstream pipe. Photo 1 of 2.

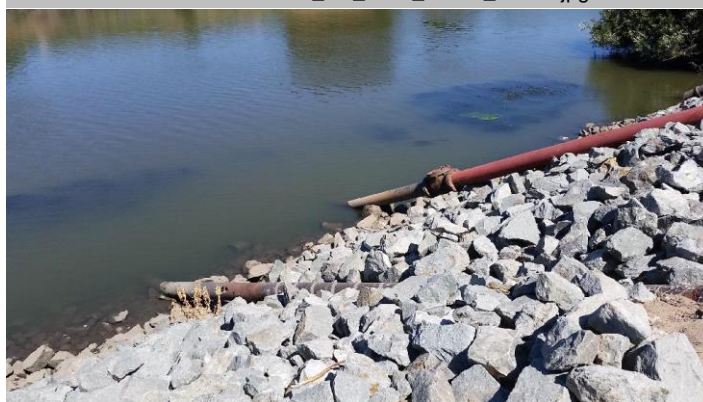
Photo 2 of 3 : UCIP\_SP\_2020\_53329\_75733.jpg

View of WS, photo taken upstream looking at first pipe. Photo 1 of 2.

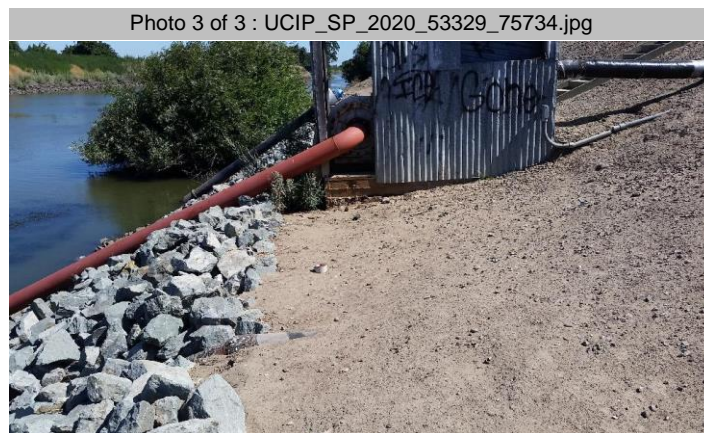
WS-pipe daylight just above rip rap near red pipe.

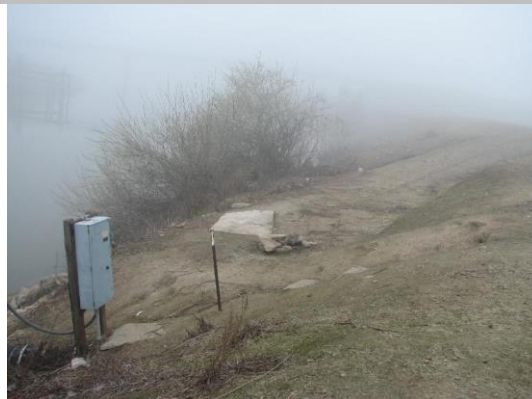
Photo 1 of 3 : UCIP\_SP\_2020\_40655\_72050.jpg

DS\_ID:20  
FS\_ID:40655  
EP\_NO: 15106  
Repair Type: Non-Urgent  
Crossing Status: Found  
UCIP Comments: Burrow activity dession on landward slope. Need to coordinate with owner to determine status of crossing. If crossing is no longer in use owner will need to contact the CVFPB to comply with Title 23.  
FIELD\_STRUCT\_DESC: 10-inch steel irrigation pipe through levee, 3.27 feet below levee crown. Siphon breaker on landside (LS) shoulder. Pump on waterside (WS) slope, standpipe located 14 feet LS of levee toe. (10-inch installed and existing 12-inch pipe removed under Permit No. 15106, 1989-A.J. Rodgers Estate - C/O Opal Rodgers; pipe was installed during the levee work approved under Permit Number 15014, 1989-Reclamation District No. 17 [RD0017]) [Additional Reference(s): DWR Levee Logs, 1981, 2003]  
FS Date: 2/4/2010

View of waterward side.

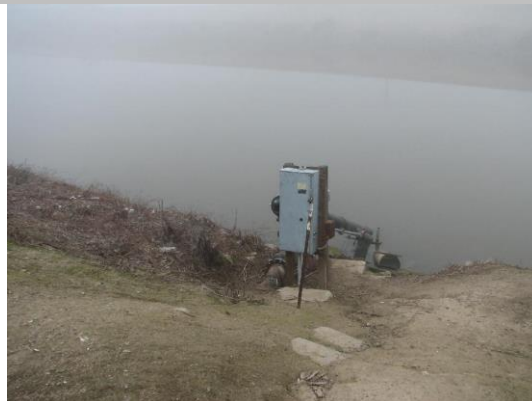
Photo 2 of 3 : UCIP\_SP\_2020\_40655\_72051.jpg

Pump station and control panel located on waterward side.

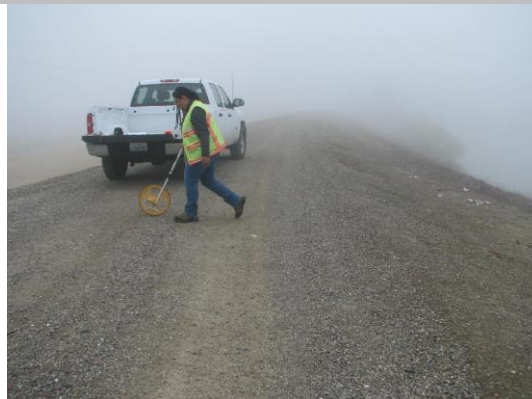
Photo 3 of 3 : UCIP\_SP\_2020\_40655\_72049.jpg

View of levee crown at crossing.

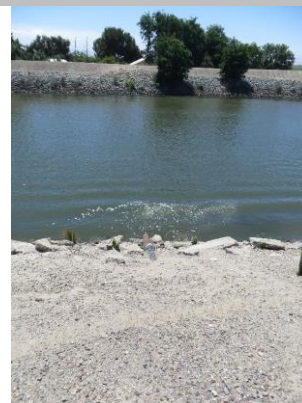
Photo 1 of 3 : UCIP\_SP\_2020\_46005\_74456.jpg

DS\_ID:21  
FS\_ID:46005  
EP\_NO: 15310  
Repair Type: Non-Urgent  
Crossing Status: Found  
UCIP Comments: 05/19/15 Deteriorated section of pipe has been replaced. Need to contact KSN, engineering consulting representing LMA, to determine repair details and to obtain permit authorizing repair. 02/04/10 Pipe wall deteriorated. Need to coordinate with owner to determine status of crossing. If crossing is no longer in use owner will need to contact the CVFPB to comply with Title 23.  
FIELD\_STRUCT\_DESC: 10-inch steel drainage pipe through levee, 4-feet below crown. Siphon breaker on landside (LS) shoulder. Pump located on the LS approximately 45 feet from the levee toe. (10-inch pipe installed (per As-builts), 8-inch referenced in permit records, and existing 6-inch pipe removed (two existing pipes removed), work authorized under Permit No. 15310, 1989-O. Rodgers; 10-inch pipe was installed during the levee work approved under Permit No. 15014, 1989-Reclamation District No. 17 [RD0017]). [Additional Reference(s): DWR Levee Logs, 1981, 2003]

(2015) View of waterward side.

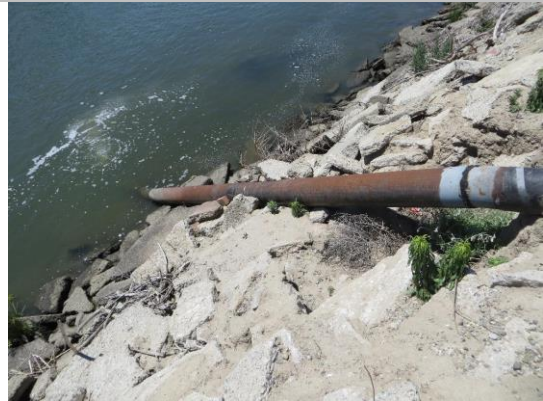
Photo 2 of 3 : UCIP\_SP\_2020\_46005\_74458.jpg

(2015) Pipe section replaced.

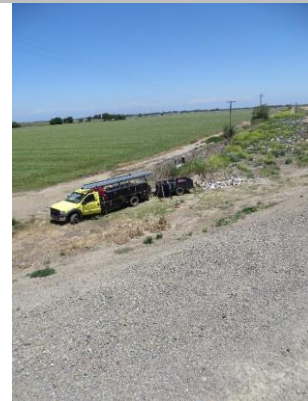
Photo 3 of 3 : UCIP\_SP\_2020\_46005\_74457.jpg

(2015) View of landward side.

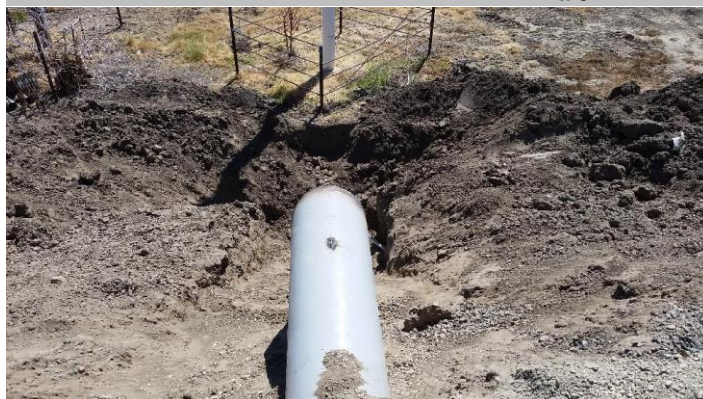
Photo 1 of 3 : UCIP\_SP\_2020\_50004\_75870.jpg

DS\_ID:25466  
FS\_ID:50004  
EP\_NO: N/A  
Repair Type: Non-Urgent  
Crossing Status: Found  
UCIP Comments: 7/12/2016 Under Construction--Missing permit information and as-built drawings. New pipe installed 7/12/2016, as an emergency repair--owner in the process of obtaining permit from CVFPB. This pipe replaces DS\_ID 22, pipe was removed July 2016. (DWR UCIP - omagana)  
FIELD\_STRUCT\_DESC: 16-inch steel irrigation pipe through the levee at an unknown depth below levee crown. Pump sits on the platform supported by steel piles located on the waterside (WS). Walkway extends from the pump platform to the WS. Positive closure device located on WS near walkway. (16-inch steel pipe installed under Permit No. XXXX, 2016 - XXXXX).  
FS Date: 7/12/2016

View of exposed pipe on LS--photo taken during install progress.

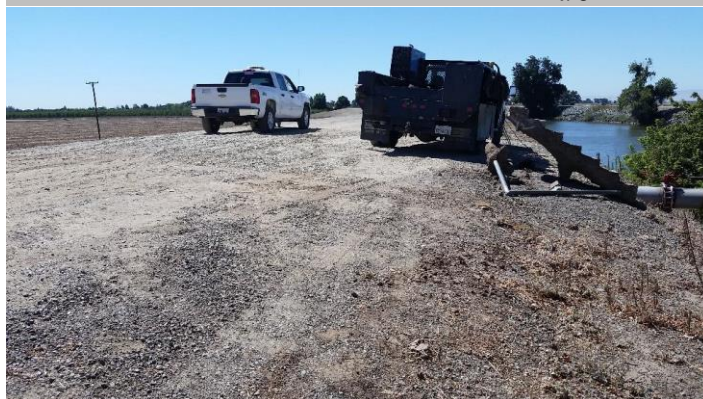
Photo 3 of 3 : UCIP\_SP\_2020\_50004\_75872.jpg

View of levee crown--construction on LS and WS in progress.

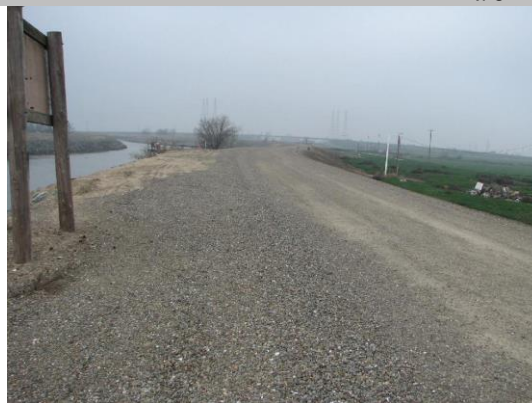
Photo 1 of 3 : UCIP\_SP\_2020\_40658\_72112.jpg

DS\_ID:23  
 FS\_ID:40658  
 EP\_NO: 4116  
 Repair Type: Non-Urgent  
 Crossing Status: Found  
 UCIP Comments: Need to contact owner to determine status of crossing. Need date of last inspection and confirmation that crossing is still in operable condition.  
 FIELD\_STRUCT\_DESC: 8.625-inch steel high pressure gas main through the levee. Invert of pipe is 3.9 feet below the crown. Location sign for gas pipeline crossing on waterside (WS) slope. PG&E contact information 510-779-4830 for crossing. (8.625-inch gas main authorized under Permit No. 4116, 1962-Pacific Gas and Electric Company [PG&E]) [Additional Reference(s): DWR Levee Logs, 1981, 2003]  
 FS Date: 2/4/2010

View of levee crown at crossing.

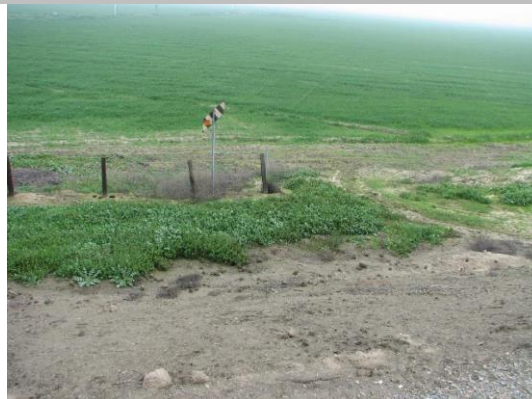
Photo 2 of 3 : UCIP\_SP\_2020\_40658\_72111.jpg

View of landward side.

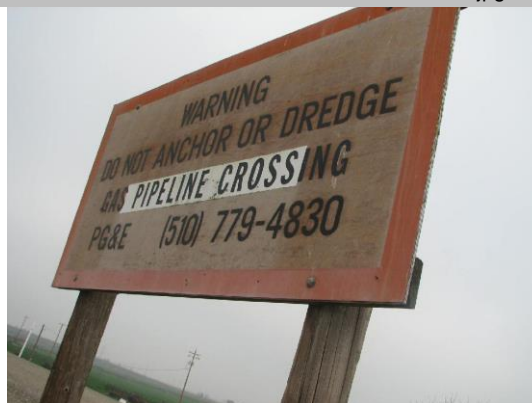
Photo 3 of 3 : UCIP\_SP\_2020\_40658\_72110.jpg

Marker visible on waterward side.

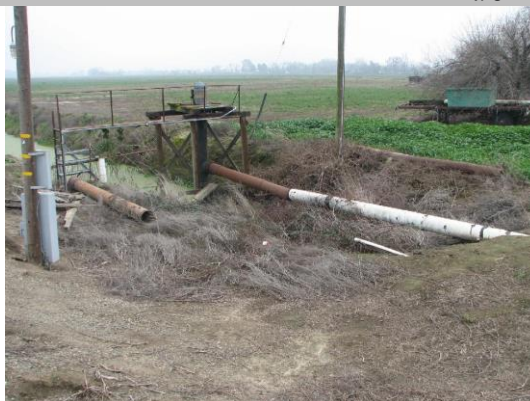
Photo 1 of 3 : UCIP\_SP\_2020\_40659\_72116.jpg

View of pipe section and pump station located on landward side.

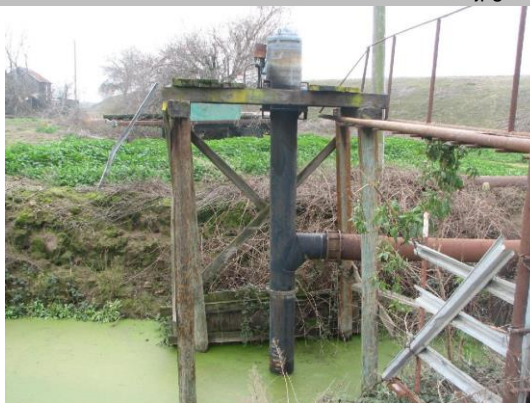
Photo 2 of 3 : UCIP\_SP\_2020\_40659\_72115.jpg

Pump station locate on landward side.

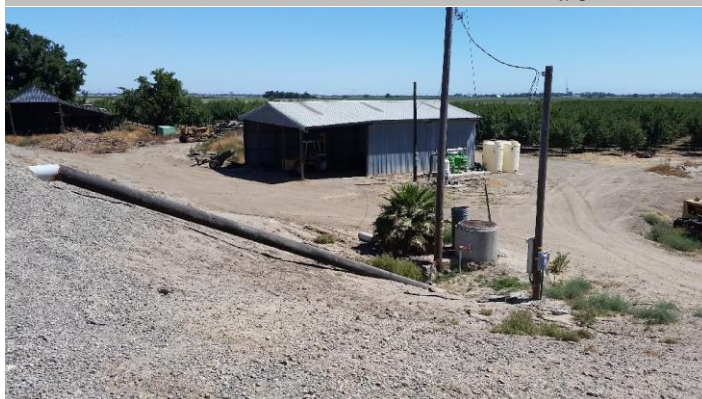
Photo 2 of 3 : UCIP\_SP\_2020\_50005\_75864.jpg

View of LS, photo taken looking downstream.

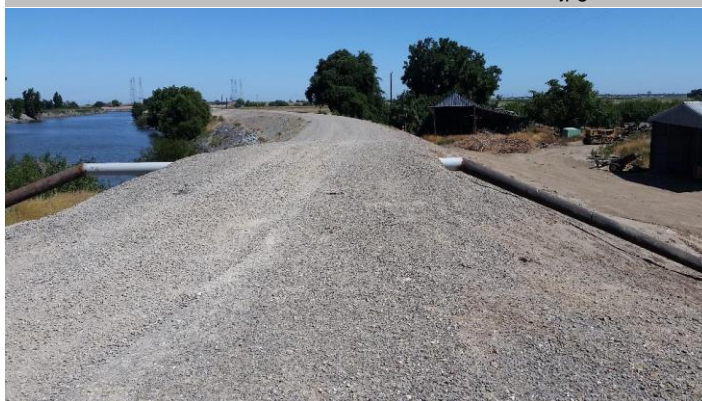
Photo 3 of 3 : UCIP\_SP\_2020\_50005\_75865.jpg

View of levee crown--levee section where pipe crosses is raised.

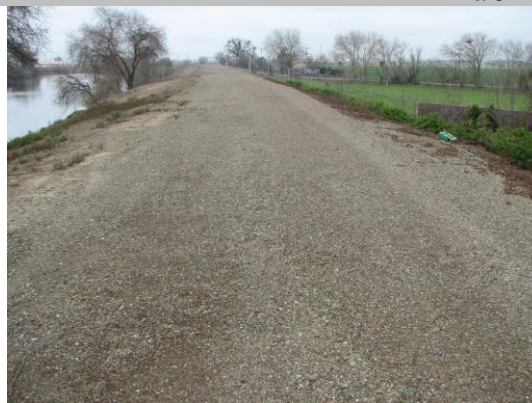
Photo 1 of 3 : UCIP\_SP\_2020\_43264\_72125.jpg

Comment Code						
Inspector Comment						
DS_ID:28 FS_ID:43264 EP_NO: 15111 Repair Type: Non-Urgent Crossing Status: Found UCIP Comments: 2/4/15--Olivia 2010 Records from KSN show this crossing was removed based on the RD17 As-Built Pipe Crossing Statining Reference, however when field verification was completed in this area a 2-inch pipe was found. This could be a different 2-inch pipe in nearby area. Need to coordinate with owner to determine permit issued for this crossing.2/4/10 Pipe is not continous. Need to coordinate with owner to determine status of crossing. If crossing is no longer in use owner will need to contact the CVFPB to comply with Title 23. FIELD_STRUCT_DESC: *REMOVED* 2-inch pipeline through levee, 3.92 feet (invert depth) below levee crown. Siphon breaker on landside (LS) shoulder. Pump on waterside (WS) slope. Pipe extends beyond 10 feet of the LS toe. (existing 2-inch removed under Permit No. 15111, 1990 - R. Jocopetti; 2-inch pipe was removed during the levee work approved under Permit No. 15014, 1989 - Reclamation District 17 [RD0017]) [Additional Reference(s): DWR Levee Logs, 1981, 2003] FS Date: 2/4/2010

View of levee crown at crossing.

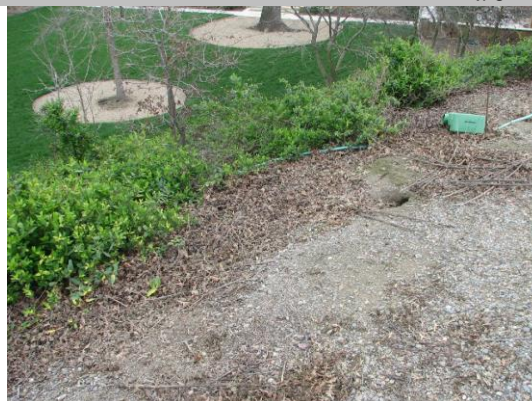
Photo 2 of 3 : UCIP\_SP\_2020\_43264\_72124.jpg

View of landward side.

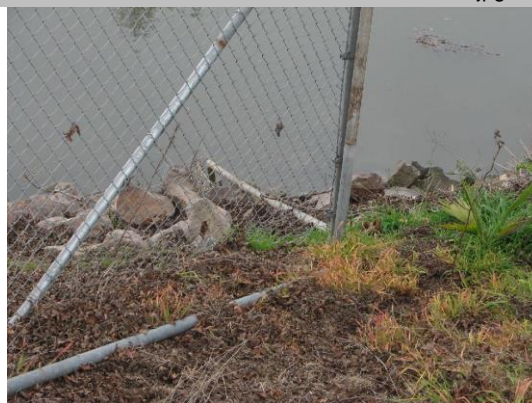
Photo 3 of 3 : UCIP\_SP\_2020\_43264\_72123.jpg

View of crossing on waterward side.

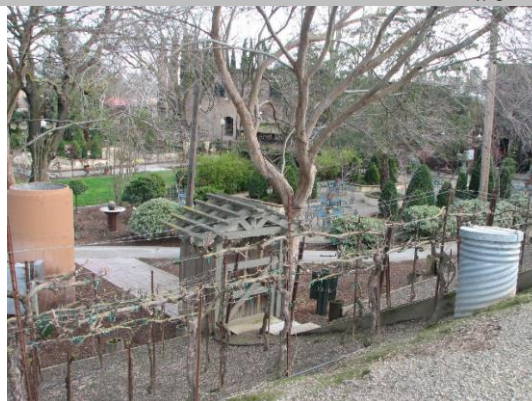
Photo 1 of 3 : UCIP\_SP\_2020\_40662\_72130.jpg

DS\_ID:29  
FS\_ID:40662  
EP\_NO: 15112  
Repair Type: Non-Urgent  
Crossing Status: Found  
UCIP Comments: Need to coordinate with owner to determine status of crossing. If crossing is no longer in use owner will need to contact the CVFPB to comply with Title 23. Debris (pipe section) scattered on waterward side.  
FIELD\_STRUCT\_DESC: 10-inch steel irrigation pipe through levee, 3.29 feet below crown. Siphon breaker on landside (LS) shoulder. Pump on waterside (WS) berm, standpipe located 28 feet from the LS toe. Stairway located on both WS and LS slopes. (10-inch pipe installed and existing 10-inch pipe removed under Permit No. 15112, 1990 - C. Marshall; 10-inch pipe was installed during the levee work approved under Permit No. 15014, 1989 - Reclamation District 17 [RD0017]) [Additional Reference(s): DWR Levee Logs, 1981 and 2003]  
FS Date: 2/4/2010

View of landward side.

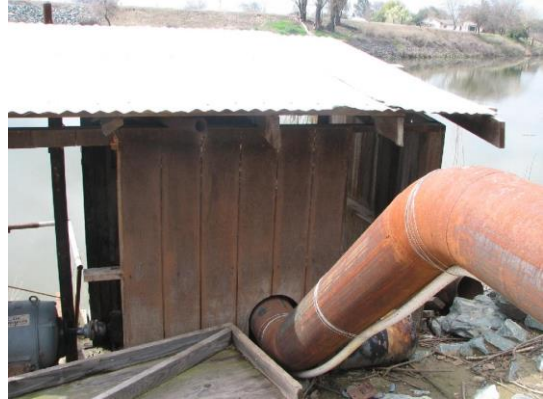
Photo 3 of 3 : UCIP\_SP\_2020\_40662\_72134.jpg

Pipe through pump house located on waterward side.
